UNIT CONSTRUCTION OF TROUT HABITAT IMPROVEMENT STRUCTURES FOR WISCONSIN COULEE STREAMS

Administrative
Report No. 27

Bureau of Fisheries Management
Department of Natural Resources
Madison, Wisconsin

August 1988

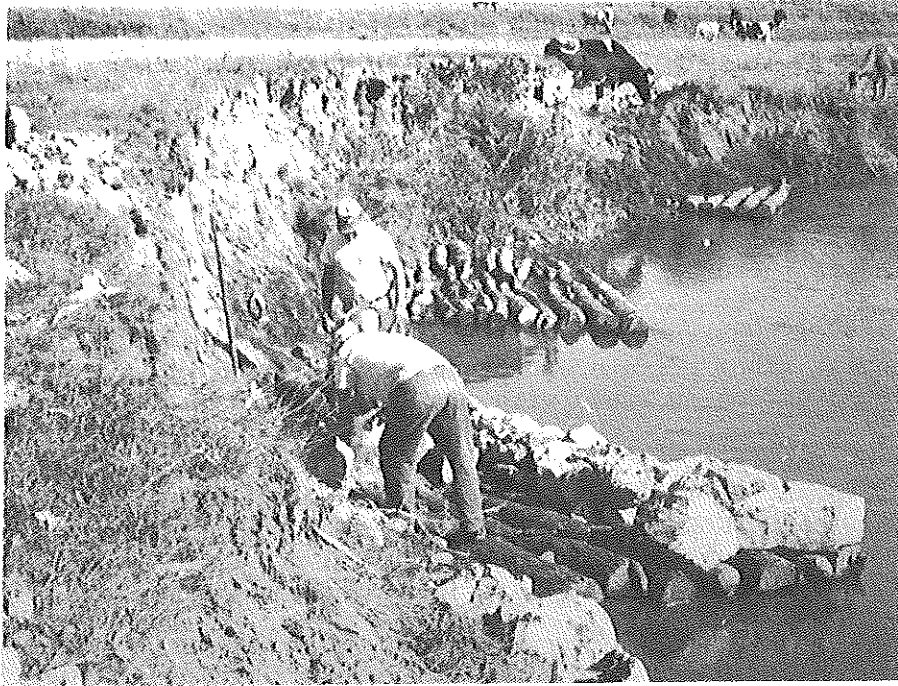
FIGURE 1. Installation of early log wing deflectors, La Crosse Area.

Logs cut along the stream bank were the usual source of materials for wing deflectors. Two short logs, called anchor logs, were placed in the stream perpendicular to the bank. Another log, called a face log, was placed parallel to the stream bank on top of the anchor logs. Both the anchor log and face log were then wired to steel fence posts driven into the streambed on the inside corners of the logs. The ends of the wire were anchored using fence staples. Additional logs were placed between the face log and the stream bank. A length of hog wire was then stapled to the log structure to help hold the structure together. Riprap rock was placed on top of the structure, and the area behind each structure was sloped, raked, and seeded (Fig. 1).

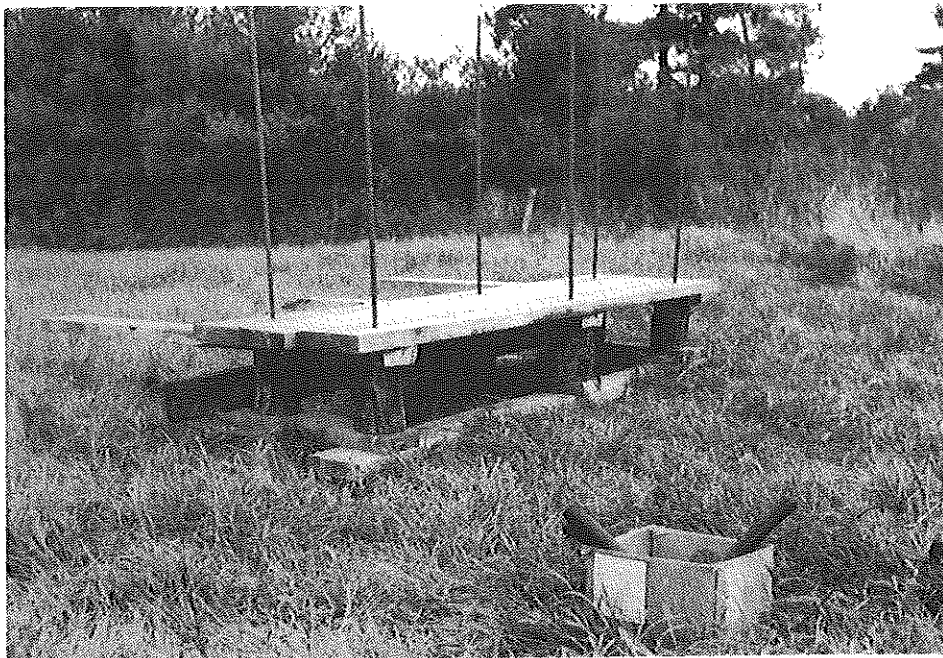
FIGURE 7. La Crosse Area's LUNKERS unit.

When all the materials are at hand, two experienced people can assemble and nail the structures together in 11 minutes (Fig. 7). Complete installation of 3-5 structures on an outside bend of a stream can be accomplished in about four hours with a crew of four. This includes all cutting, drilling, construction, rocking (placing face rocks and backfilling with pit run riprap), landscaping, raking, and seeding. The structures can be built near the installation site while the site is being prepared, eliminating the lag time required for installation of log structures (Fig. 8).

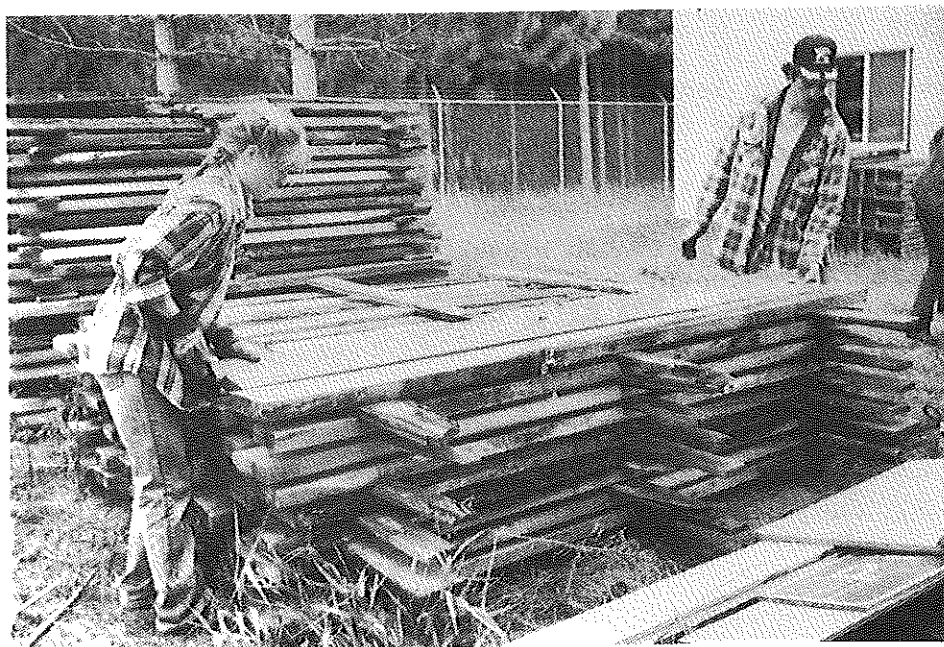
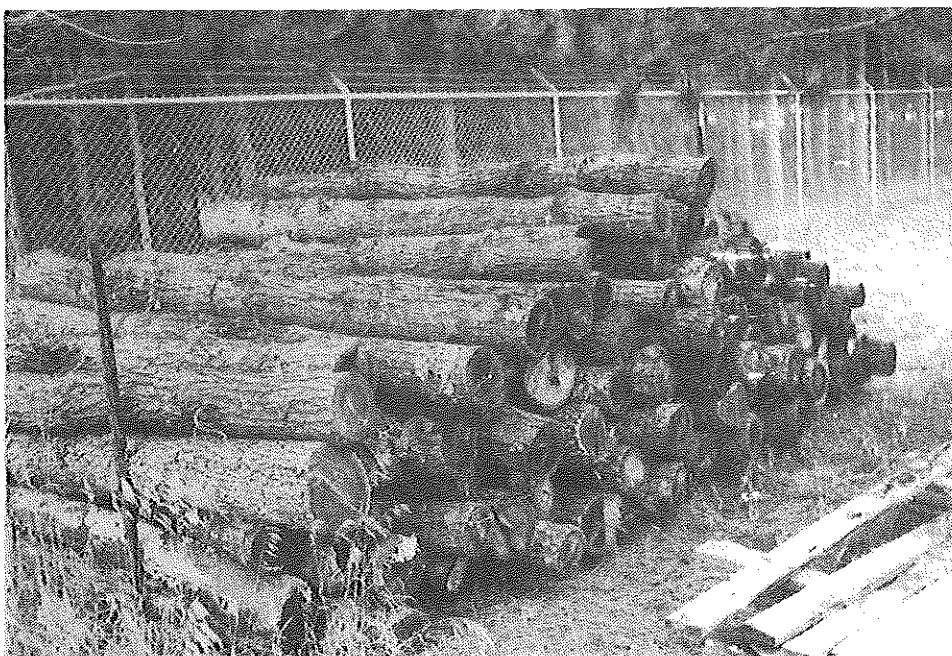
Planking and logs are also stockpiled at the job site. If the oak planking is green, it should be stacked to allow air drying, which will prevent premature rotting and soft spots (Figs. 9, 10).

FIGURE 10. Stockpiled oak logs used in the unit construction.

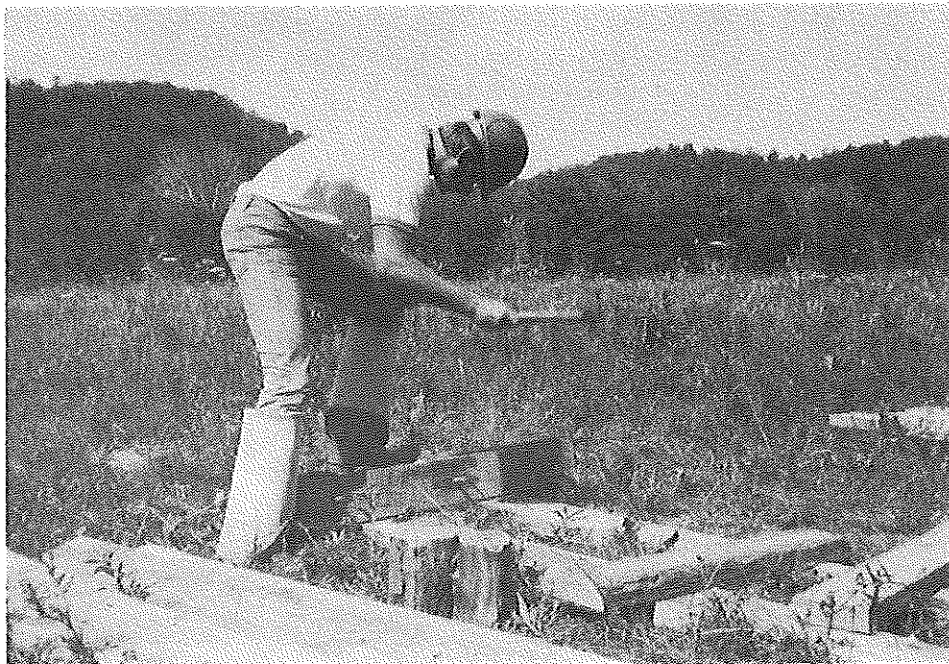
Two lengths of reinforcing rod are pushed through two blocks and a bottom stringer. The bottom stringer is then nailed to the blocks using 20D common nails. This is repeated for the remaining two stringers (Figs. 16, 17).

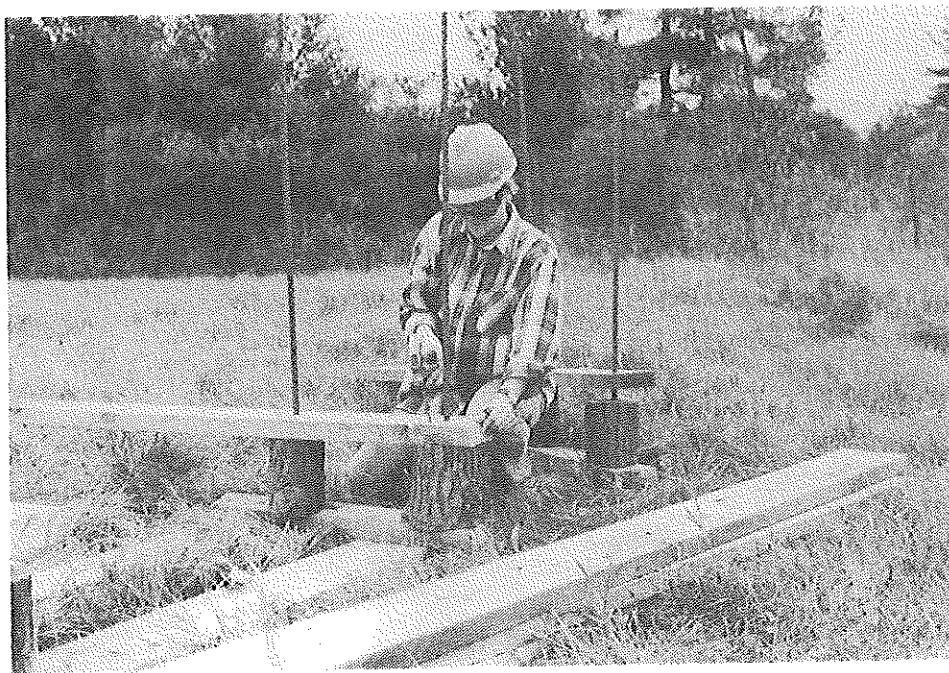
The bottom stringers are placed upright, and a rod is centered through each of the holes in the top stringers. The top stringers are then pushed down to the top of the blocks and nailed (Figs. 18, 19).

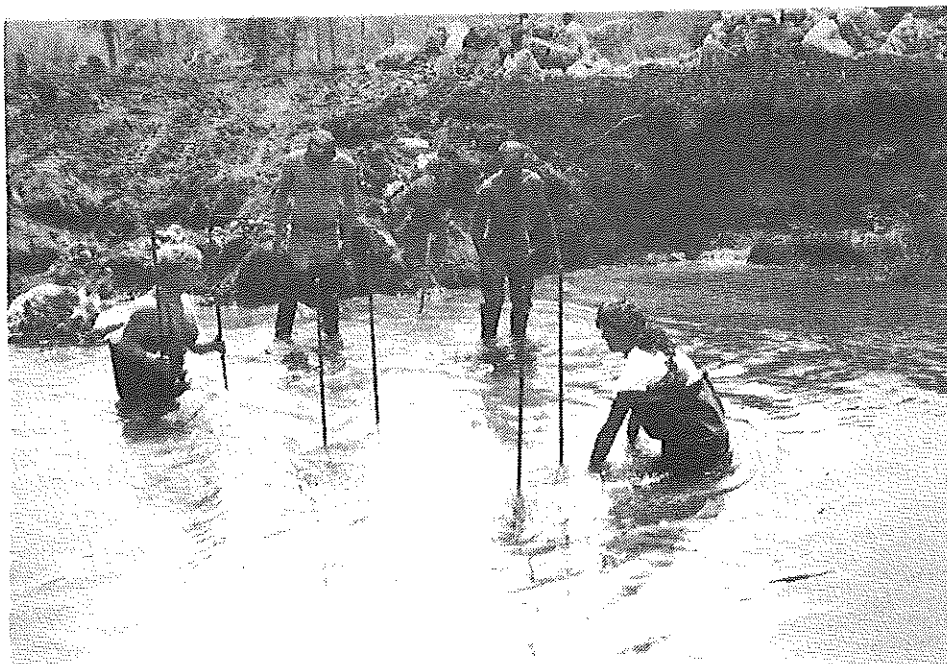
FIGURE 26.

Once the structure is placed in the stream, it can be easily moved into place by two crew members (Fig. 26). The top of the structure should be at least 6 inches below the surface of the water. Care should be taken to keep the structure as level as possible. A level structure will allow easier installation of face rock.

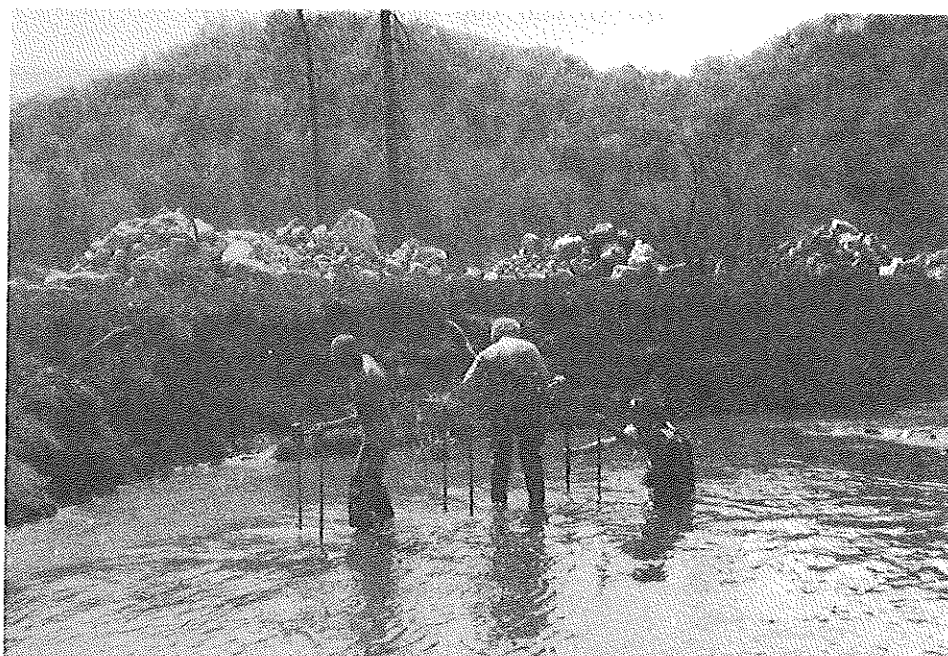
FIGURE 27.

When the structure is in its final location, a maul is used to drive the reinforcing rods into the streambed so the tops of the rods are flush with the tops of the planks (Fig. 27). To drive the rods below the surface of the

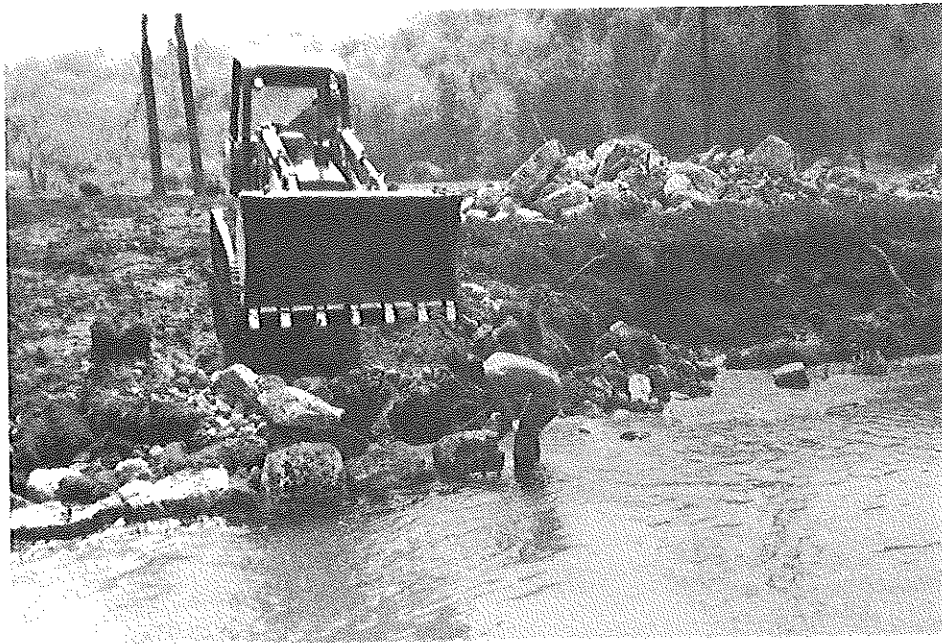
FIGURE 29.

Once all the structures have been installed, the placement of the face rock begins. When angular rocks are available, large rocks with flat bottoms and faces can be positioned on the structures using a chain hooked to the bucket of the crawler-loader and large pry bars. The front face of the rock should be flush with the front edge of the top plank (Fig. 29).

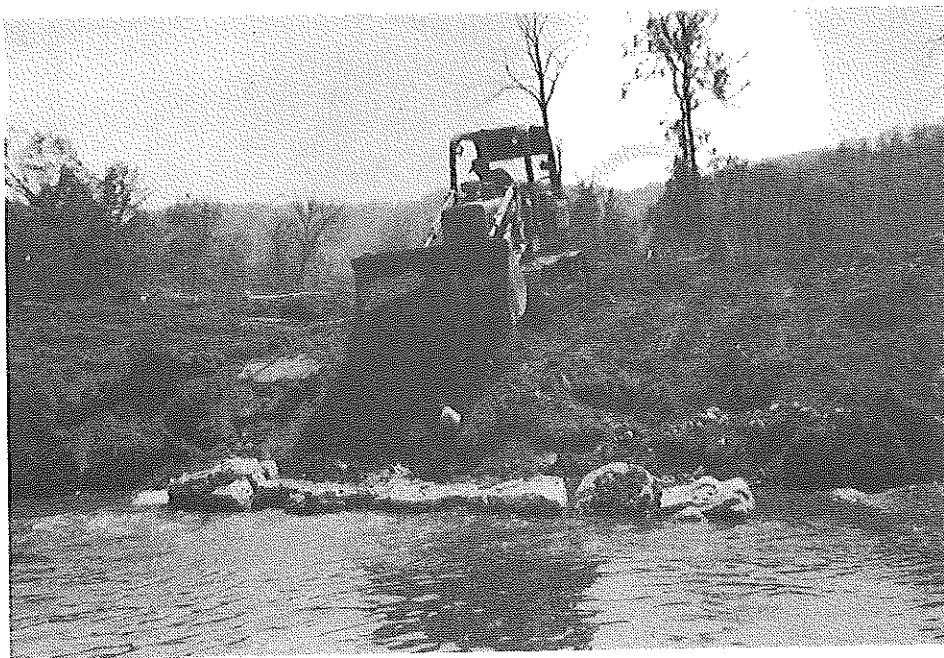
After all the face rocks have been installed, the structures are backfilled with additional rock. If enough rock is available, it should be installed to the level of the normal high water mark. Large rocks should also be placed upstream and downstream of the structures to form a continuous line of rock around the outside bend of the stream bank (Figs. 30, 31).

FIGURE 31. Steps in LUNKERS unit construction.

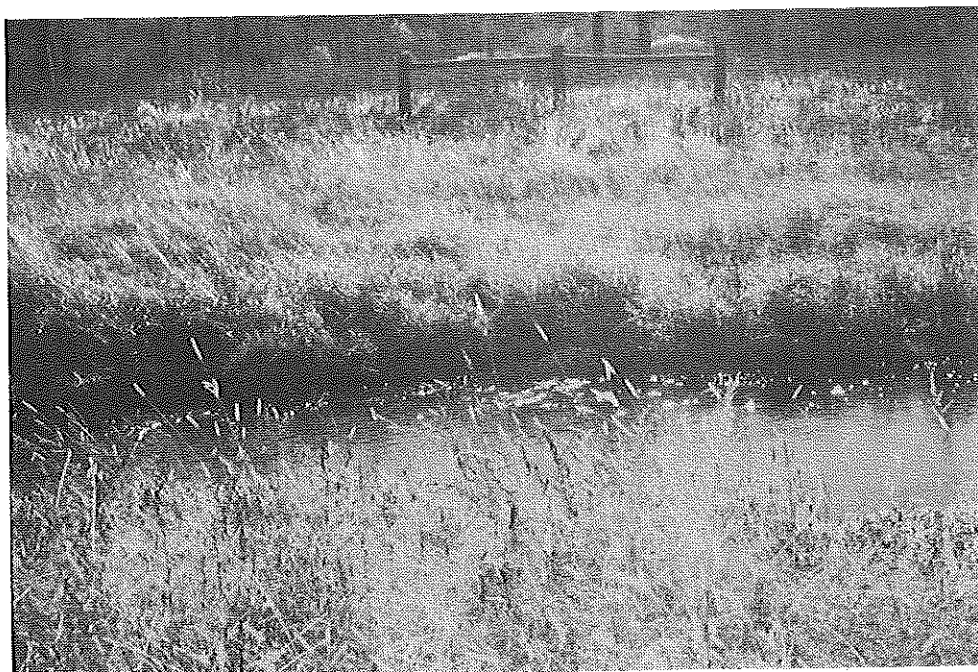
FIGURE 32.

Annual rye germinates quickly and will help protect the other seeds until they become firmly established (Fig. 32). Mulching the stream bank with straw or old hay will help prevent erosion until the grasses can take hold.

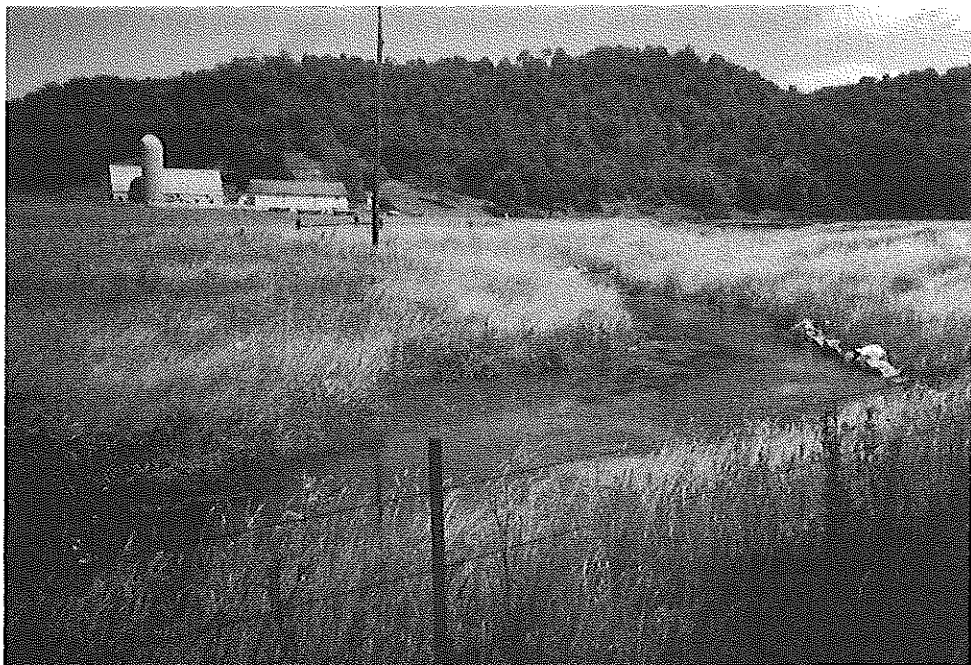
After installation of LUNKERS structures, streams that once had severe erosion, silted stream beds, and overly wide channels were virtually unrecognizable only a year after development (Figs. 36, 37). Streams that have had a major segment improved show the benefits of an intensive habitat development program. Reduction of silt as a result of stabilized stream banks, decreased surface area, increased depth and current velocity, and

FIGURE 36. Before and after habitat improvement, Timber Coulee, Vernon County, 1985-86.

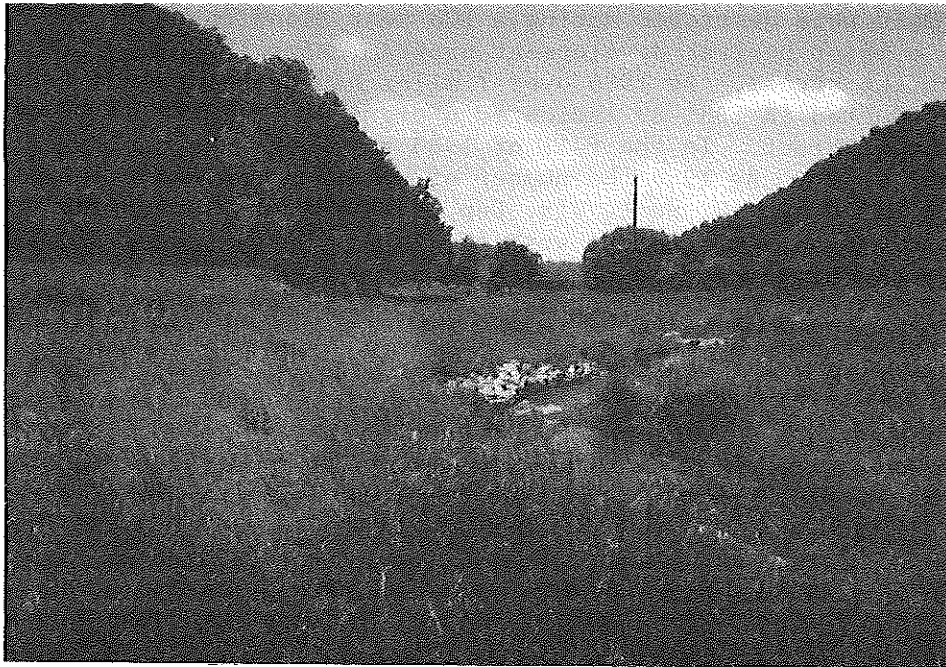
FIGURE 37. Before and after habitat improvement, Timber Coulee, Vernon County, 1985-86.
